NL INDUSTRIES/TARACORP SUPERFUND SITE GROUP
Leed Environmental, Inc.
Van Reed Office Plaza
2209 Quarry Drive, Suite C-35
Reading, PA 19609
Telephone: (610) 670-7310
Facsimile: (610) 670-7311

Re: NL Industries/Taracorp Superfund Site; Granite City, Illinois
First 2019 Semi-Annual Operation and Maintenance Inspection (May 2019)

Inspection Date: 5/20/2019

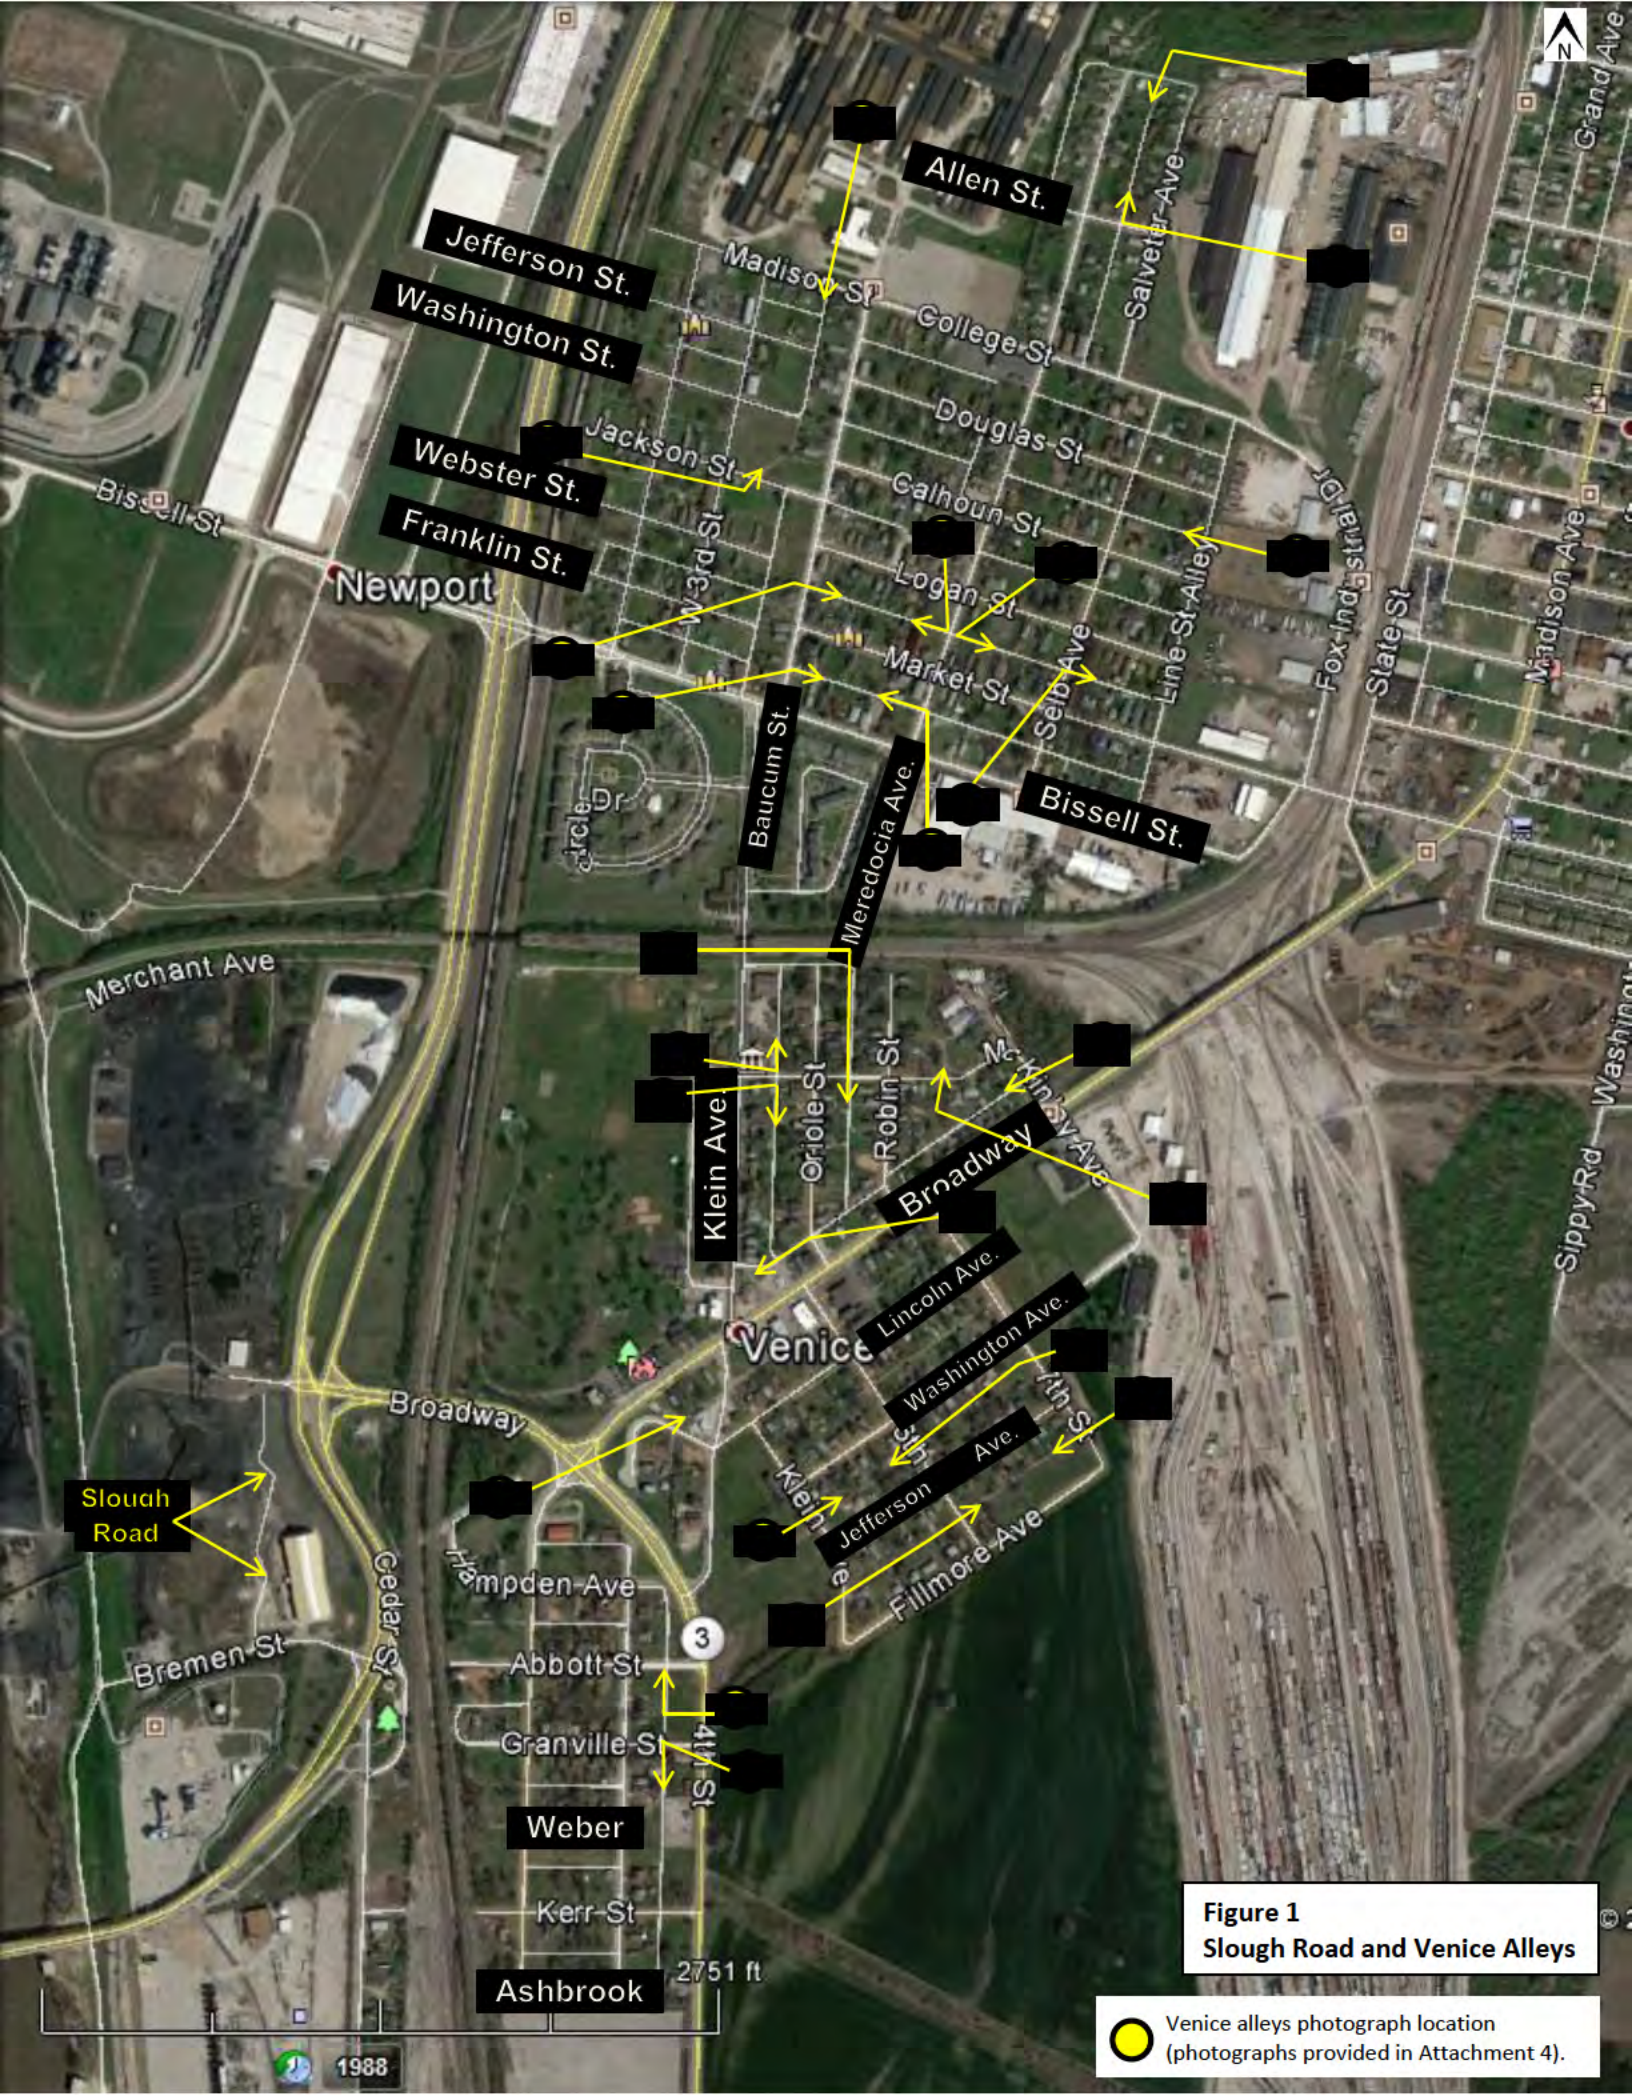
Figure 1
Slough Road and Venice Alleys

- At Slough Road (shown on Figure 1 and the photographs in Attachment 1), no disturbance of the gravel cover to the previously paved area was observed. Also, I met with Mr. Earl Boyd, Terminal Manager for Beelman River Terminals, Inc. (Beelman). Mr. Boyd confirmed that there has been no disturbance to the paved surface of Slough Road (which is no longer visible) since the time the paved roadway was covered with soil/gravel fill as part of the expansion of Beelman's operations.

- Alleys in Venice that were paved during remedial activities were inspected and noted to be in generally good condition, with some minor cracking and deterioration observed in some areas, with no battery case chips visible. The Venice alleys are shown on Figure 1 and are identified on the photographs in Attachment 4. Previous inspections have confirmed that the local municipality is continuing to repair and repave alleys, as necessary (Attachment 4, photographs 9 and 17).

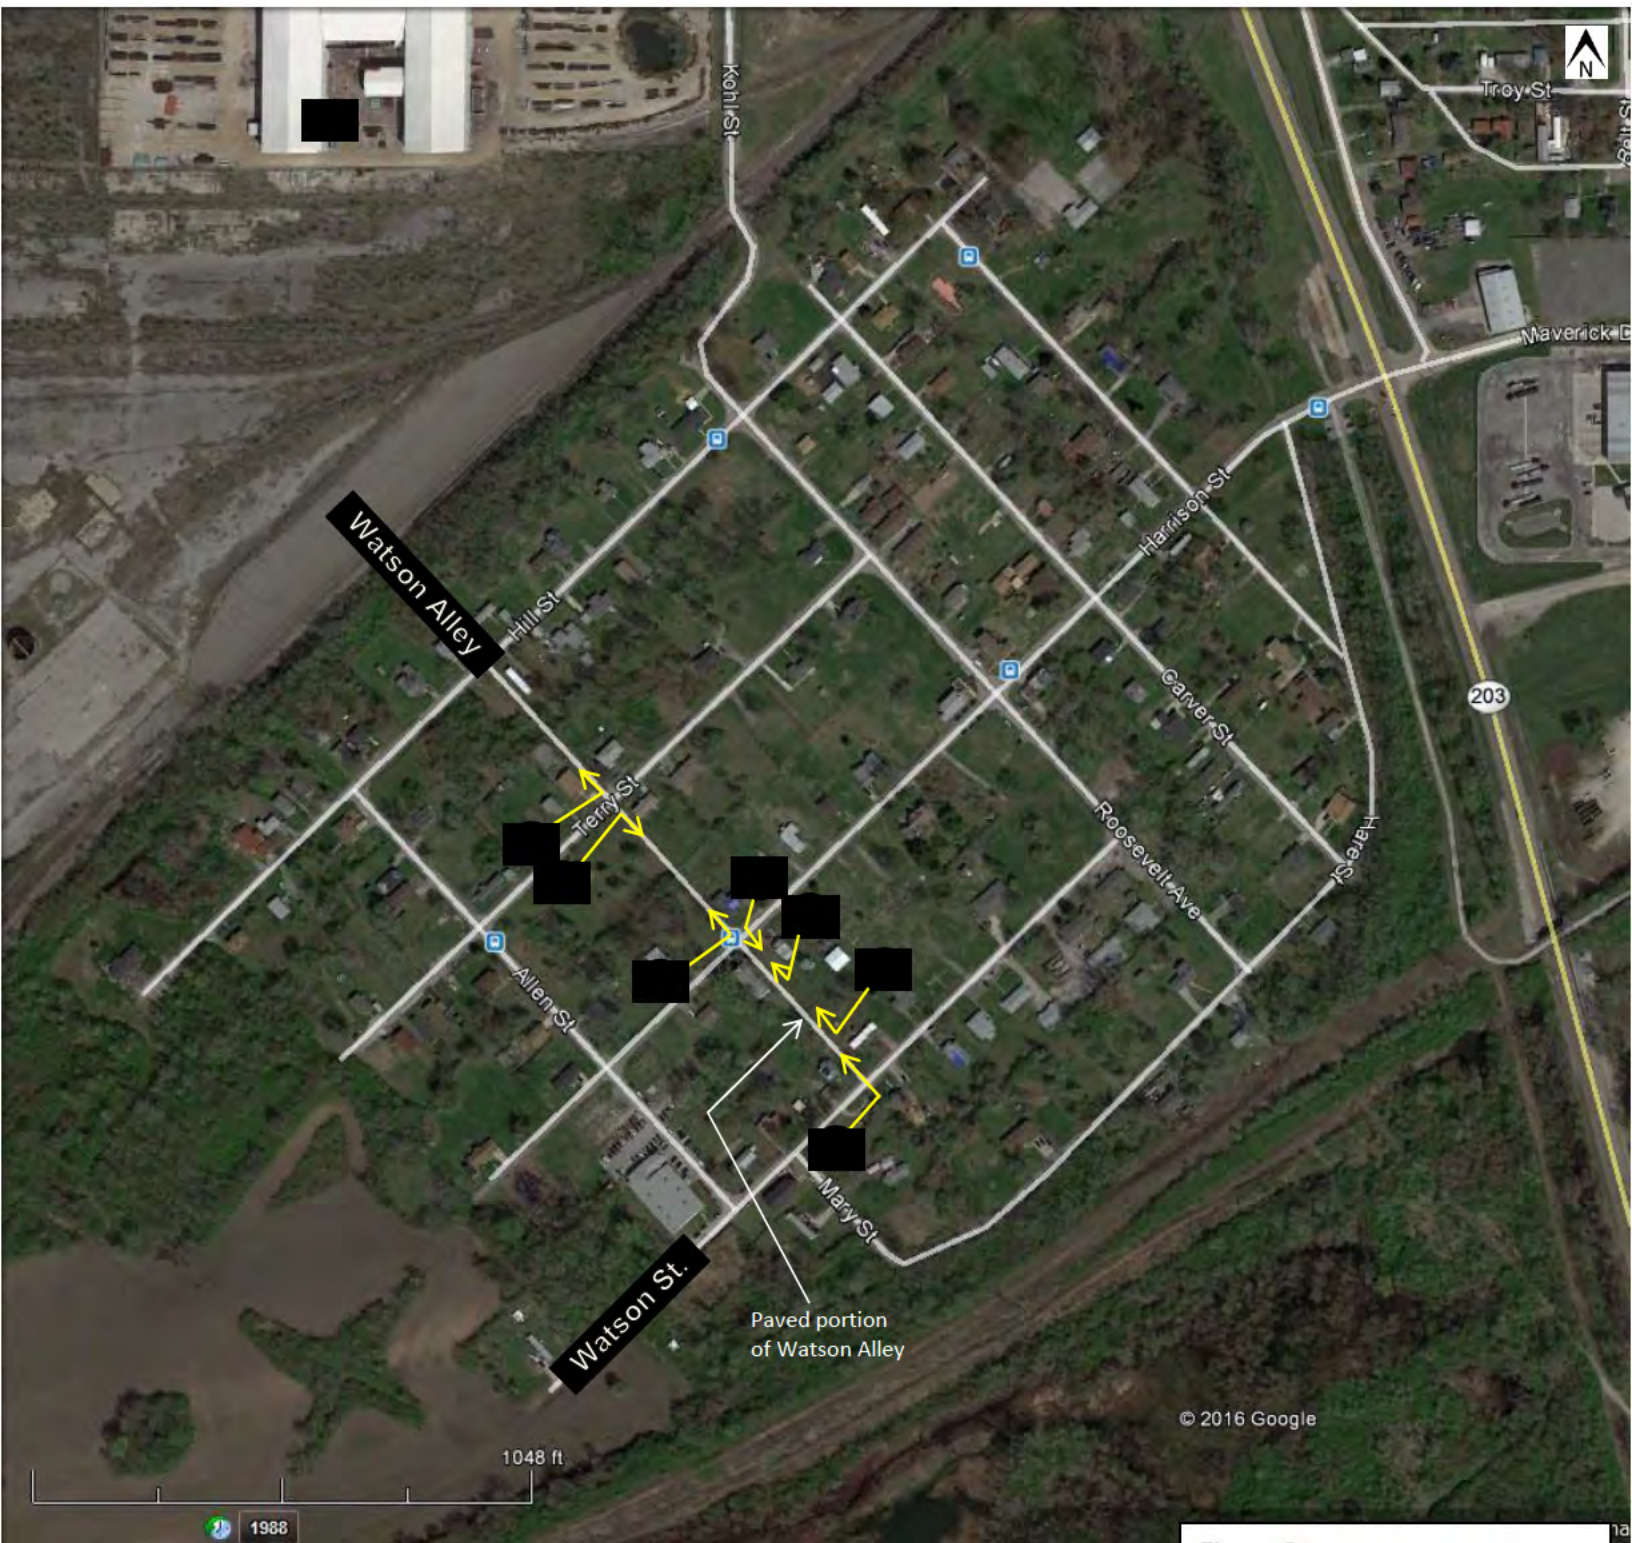
Figure 2
Eagle Park Acres – Watson Alley

- The paved portion of Watson Alley in Eagle Park Acres (shown on Figure 2 and the photographs in Attachment 2) was inspected and noted to be in good condition.

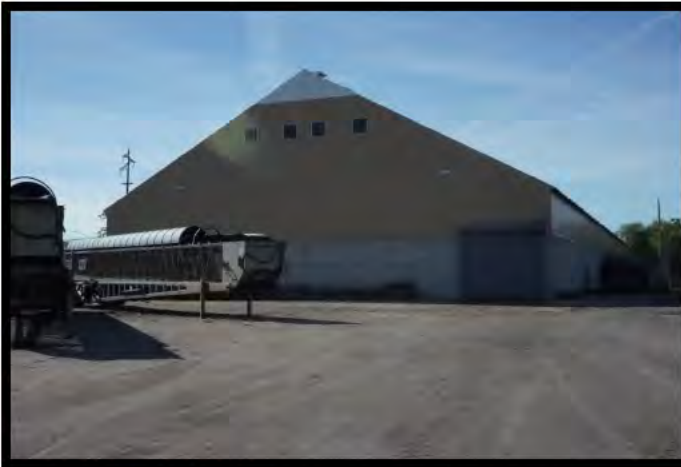
Photograph 1: Beelman storage area/warehouse.

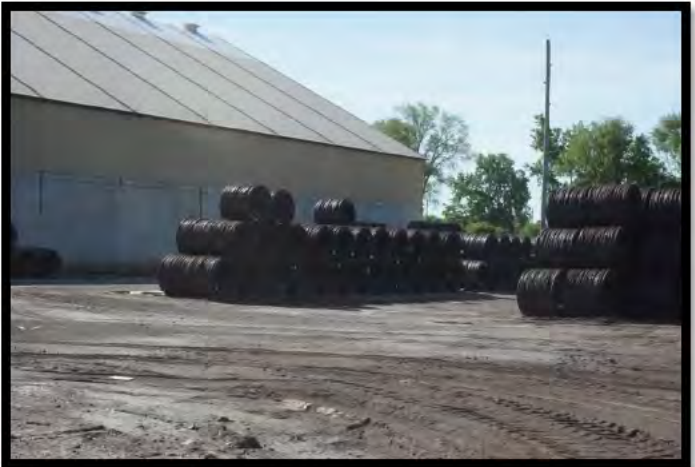
Photograph 2: Beelman storage area/warehouse.

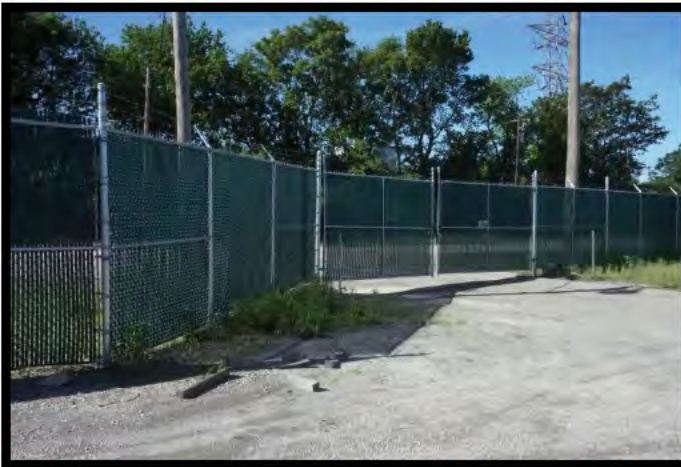
Photograph 3: Slough Road, inside fence (along Bremen Street).

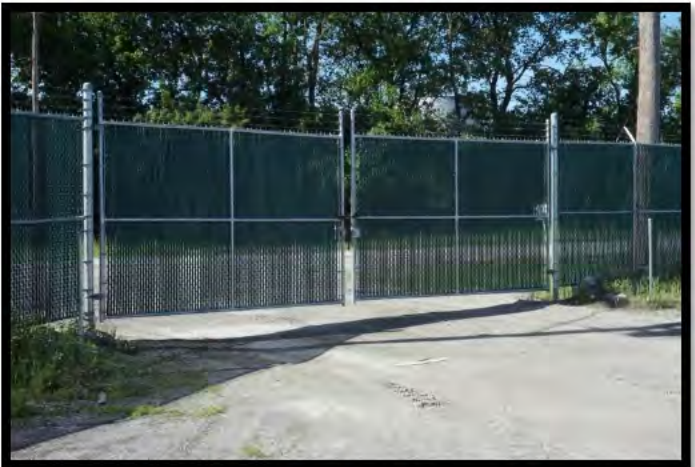
Photograph 4: Slough Road, inside fence (along Bremen Street).

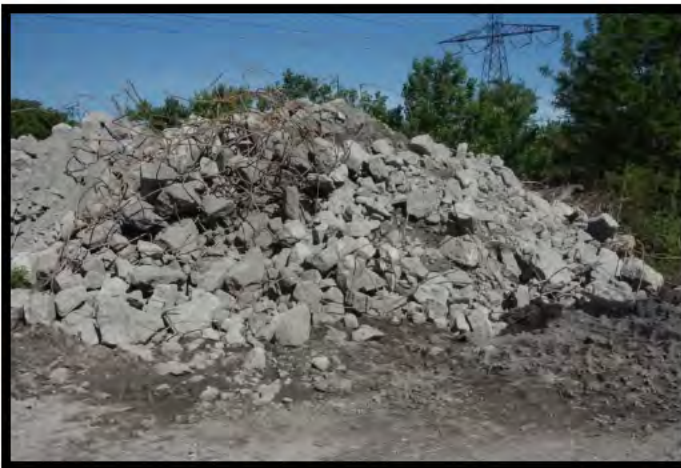
Photograph 5: Slough Road, concrete debris.

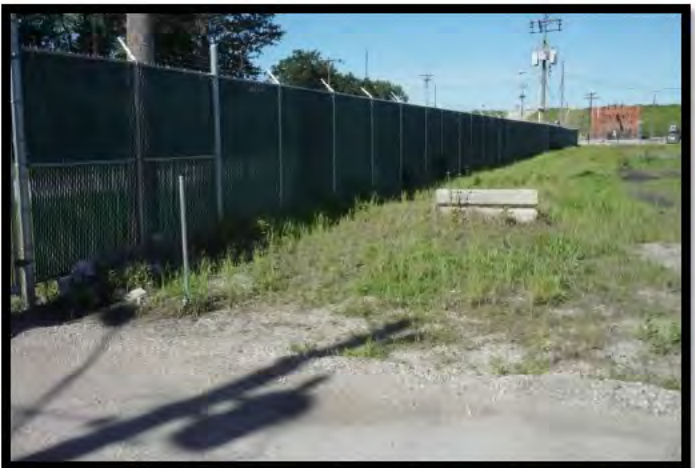
Photograph 6: Slough Road, inside fence (along Bremen Street).

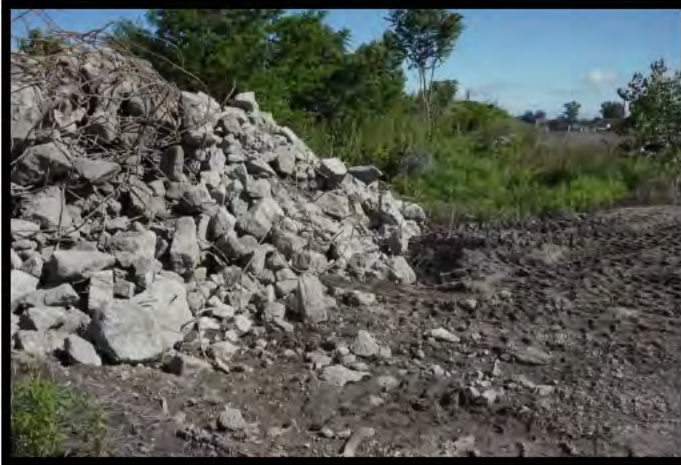
Photograph 7: Slough Road, concrete debris.

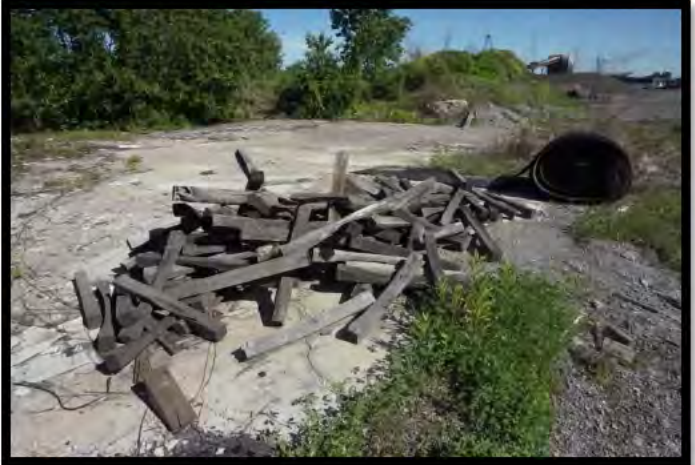
Photograph 8: Slough Road, foundation of former Robin's Nest Lounge.

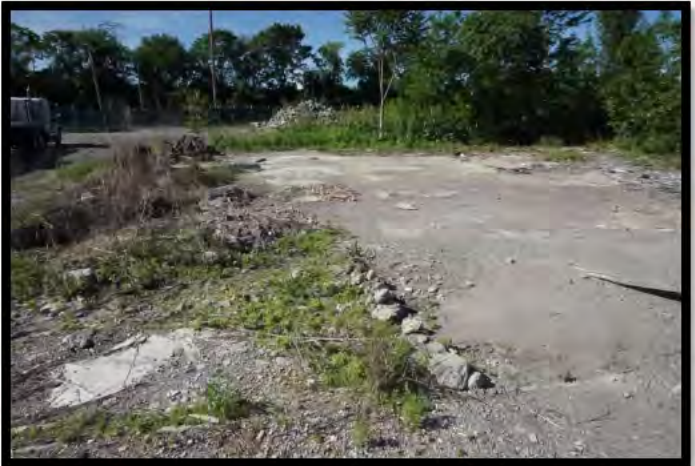
Photograph 10: Slough Road, foundation of former Robin's Nest Lounge.

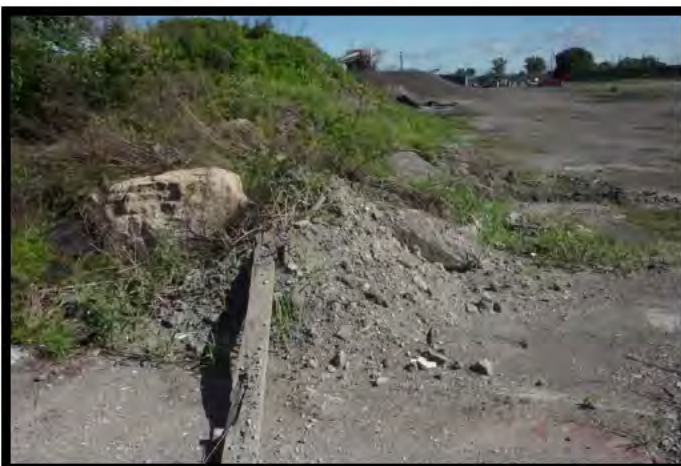
Photograph 11: Slough Road, soil pile near foundation of former Robin's Nest Lounge.

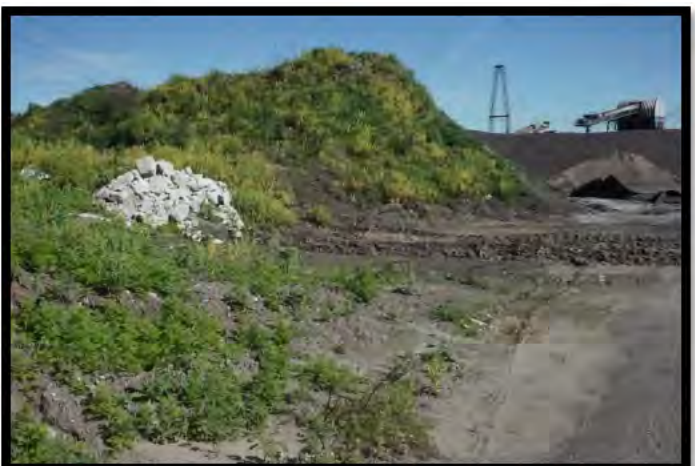
Photograph 12: Slough Road, soil pile near foundation of former Robin's Nest Lounge.

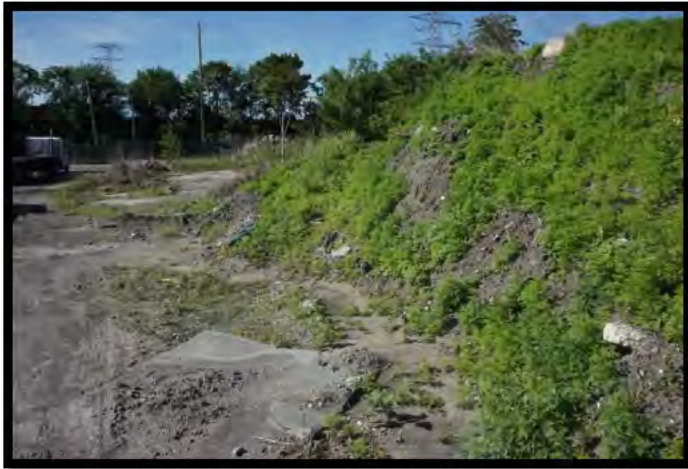
Photograph 13: Slough Road, soil pile near foundation of former Robin's Nest Lounge.

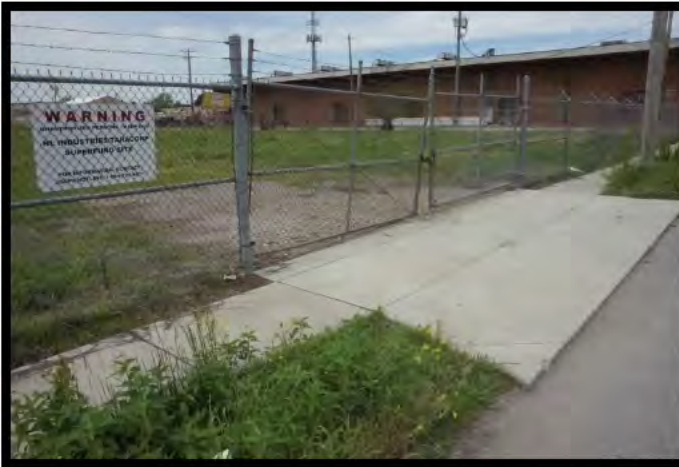
Photograph 1: Entrance to 1555 State Street property along State Street.

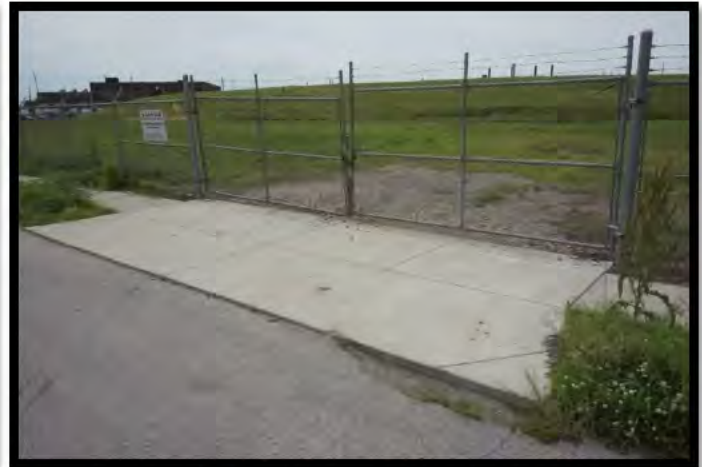
Photograph 2: Entrance to 1555 State Street property along State Street.

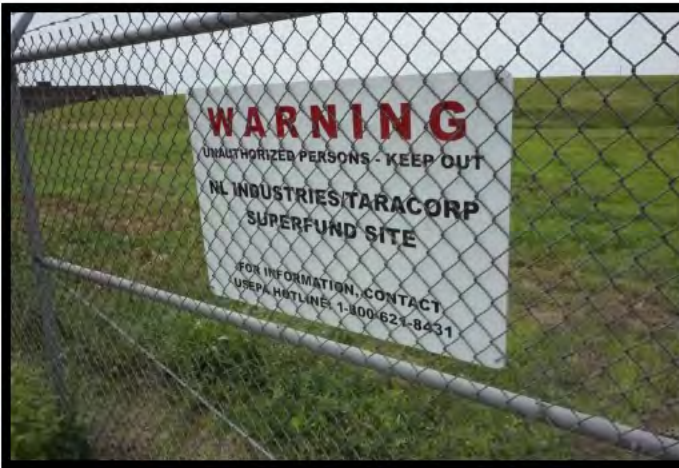
Photograph 3: Warning sign at front gate along State Street.

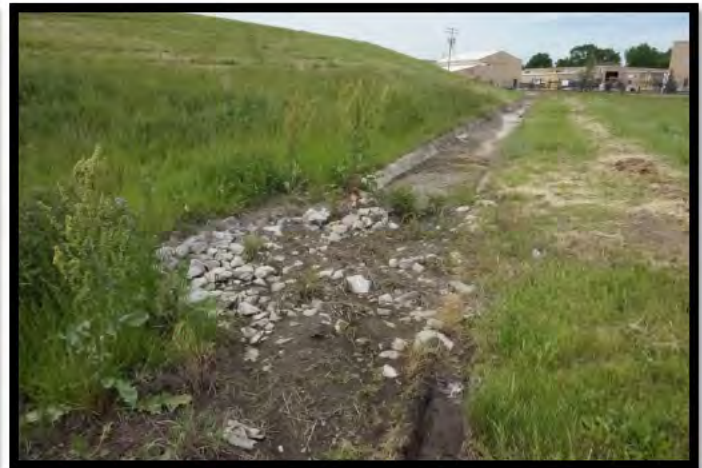
Photograph 4: Concrete drainage swale, east side of Taracorp pile (view north).

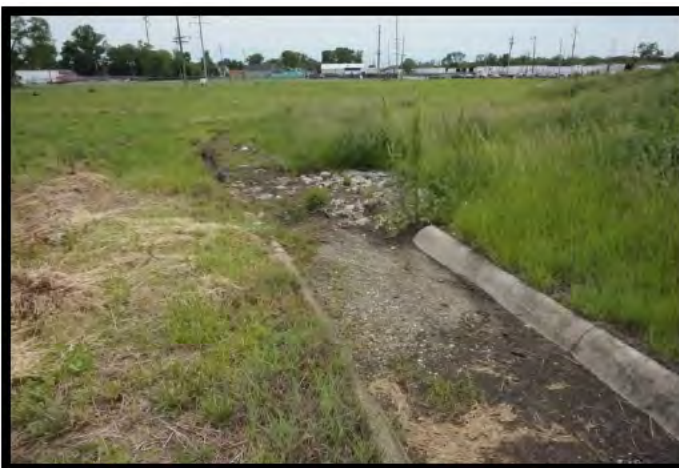
Photograph 5: End of concrete drainage of swale, east side of Taracorp pile.

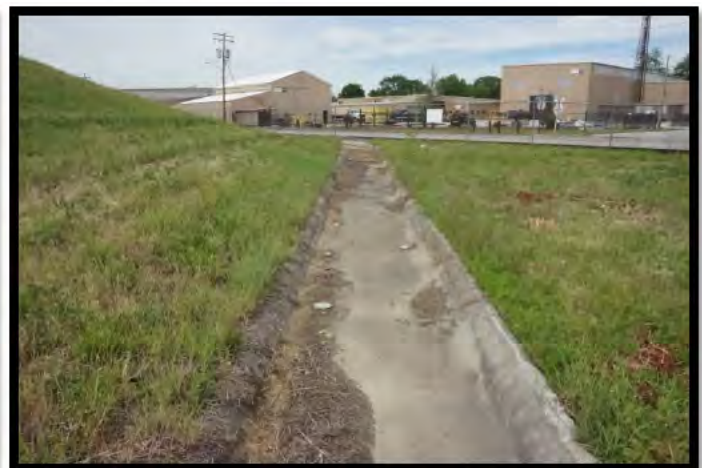
Photograph 6: Concrete drainage swale, east side of Taracorp pile (view north).

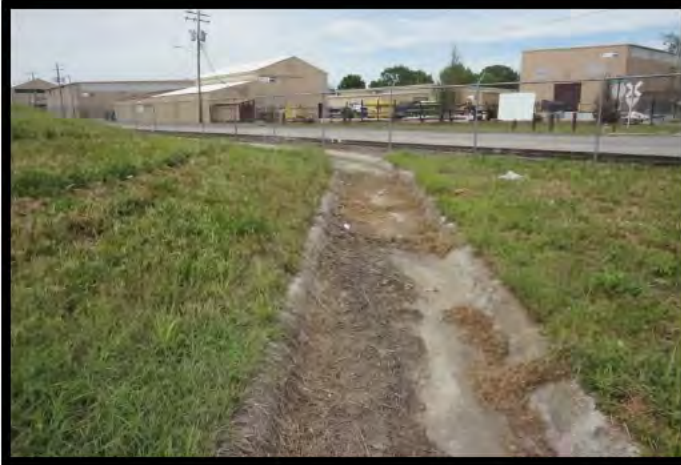
Photograph 7: Concrete drainage swale, east side of Taracorp pile (view north).

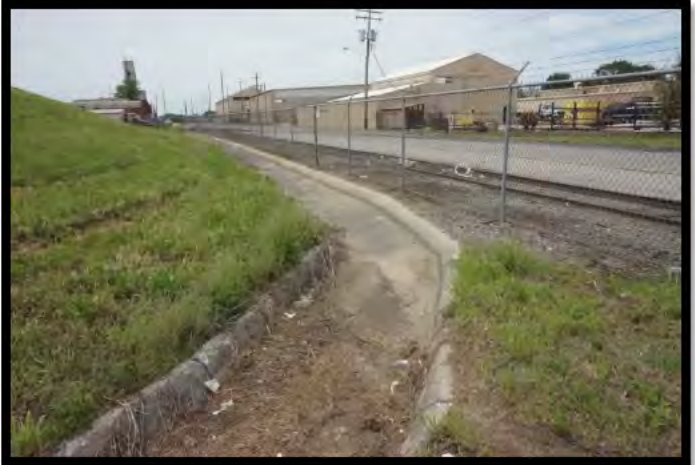
Photograph 8: Concrete drainage swale, east side of Taracorp pile (view north).

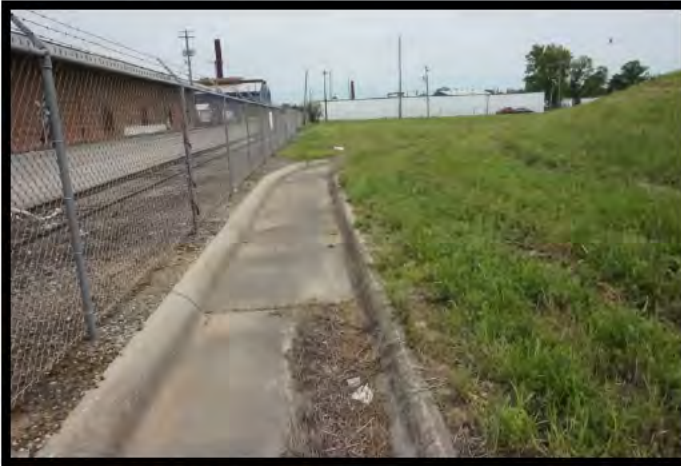
Photograph 9: Concrete drainage swale, north side of Taracorp pile (view southeast).

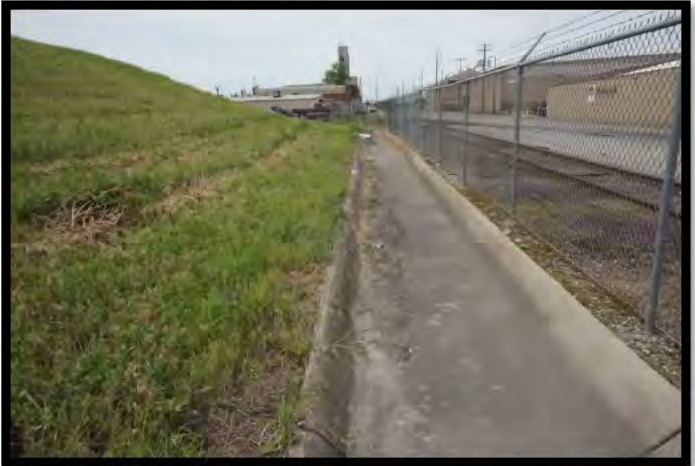
Photograph 10: Concrete drainage swale, fence, and vegetation; north side of Taracorp pile along 16th Street (view northwest).

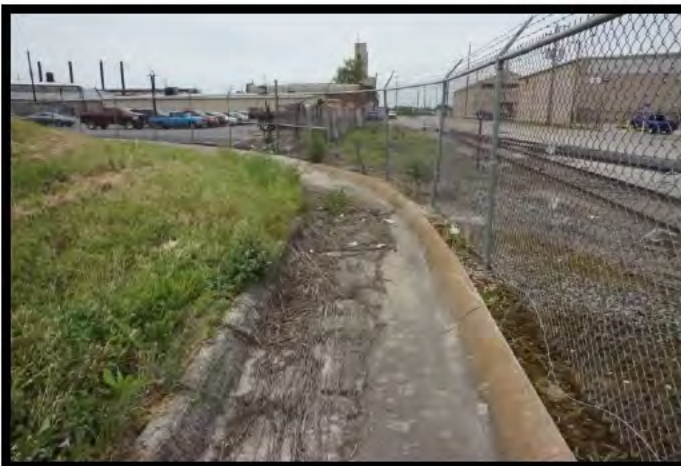
Photograph 11: Concrete drainage swale, fence, and vegetation; north side of Taracorp pile along 16th Street (view northwest).

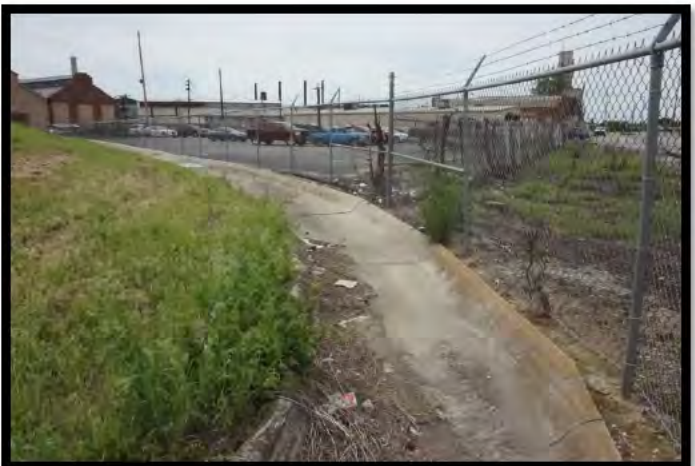
Photograph 12: Concrete drainage swale, fence, and vegetation; north side of Taracorp pile along 16th Street (view northwest).

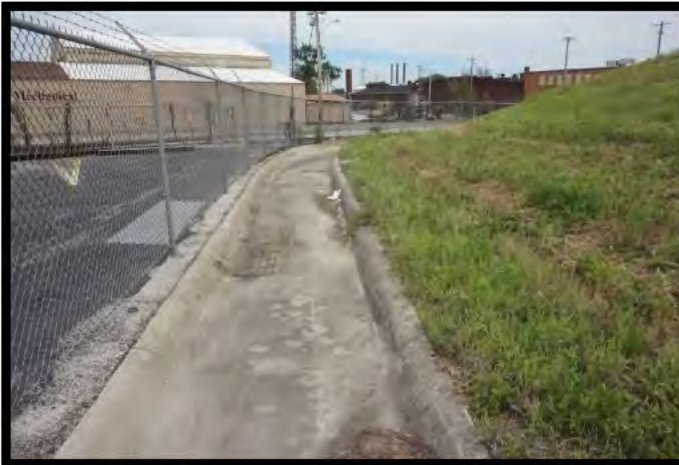
Photograph 13: Concrete drainage swale and vegetation; northwestern side of Taracorp pile (view northeast).

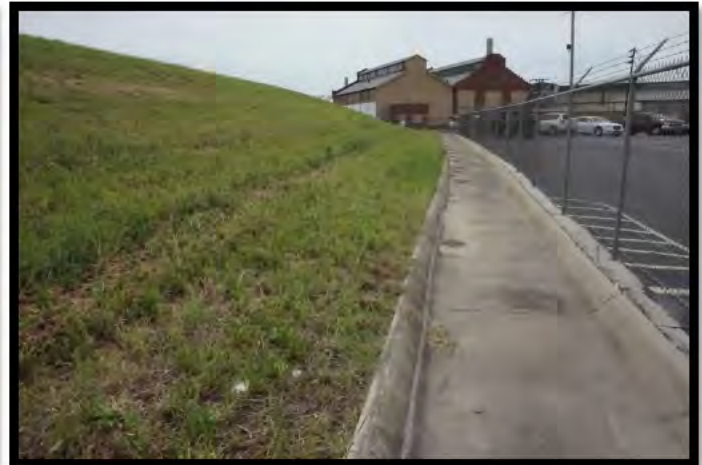
Photograph 14: Vegetation, northwestern side of Taracorp pile cap (view southwest).

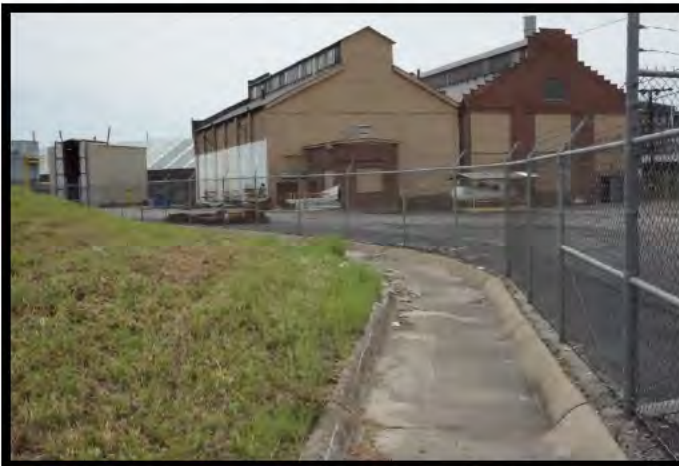
Photograph 15: Concrete drainage swale, fence, and vegetation along northwestern side of Taracorp pile (view southwest).

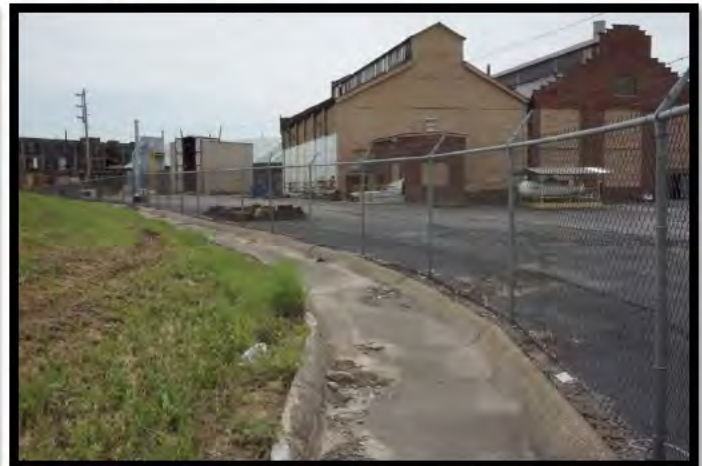
Photograph 16: Concrete drainage swale, crack in concrete along northwestern side of Taracorp pile.

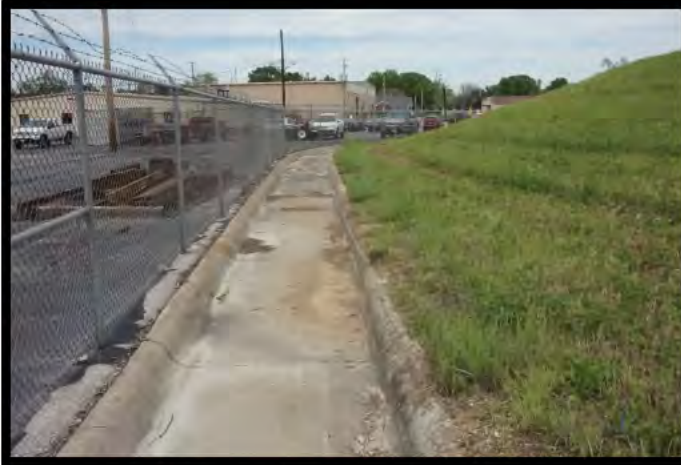
Photograph 19: Concrete drainage swale, vegetation along northwestern side of Taracorp pile (view north/northeast).

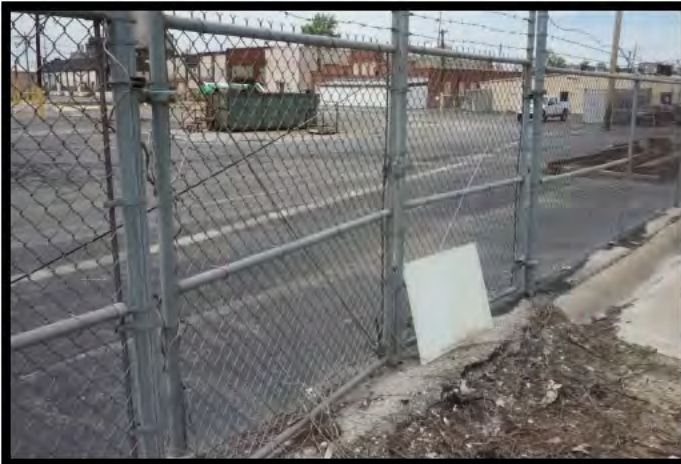
Photograph 21: Fence, warning sign (fallen from fence), western side of Taracorp pile.

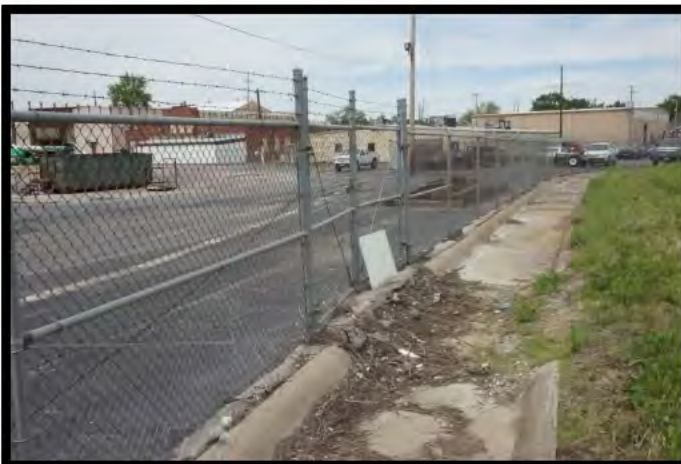
Photograph 23: Fence, warning sign (fallen from fence), western side of Taracorp pile.

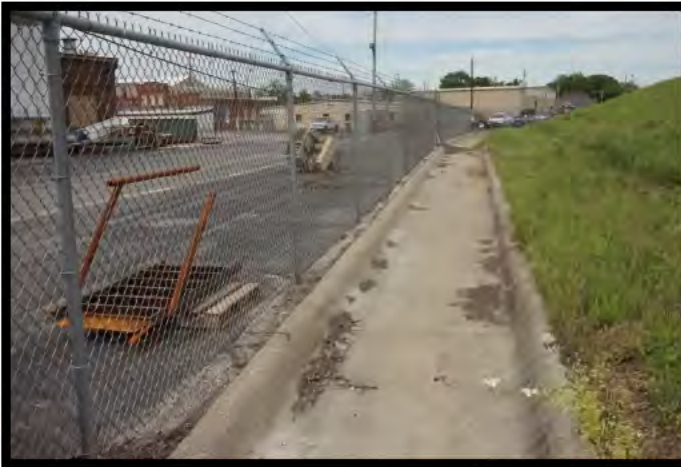
Photograph 25: Concrete drainage swale and vegetation near base of western side of Taracorp pile (view north).

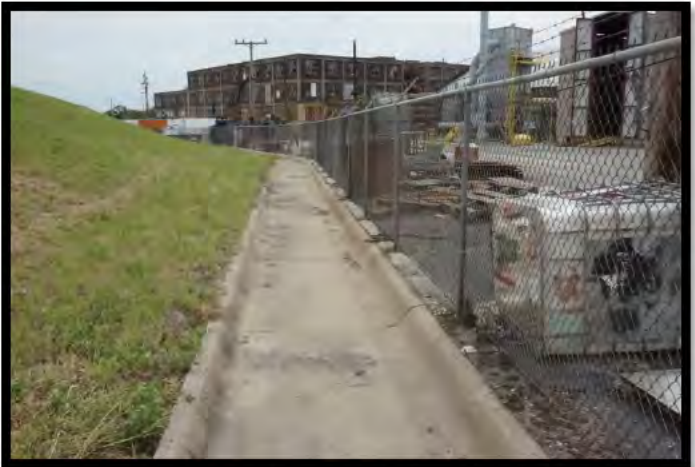
Photograph 26: Concrete drainage swale and vegetation near base of western side of Taracorp pile (view south).

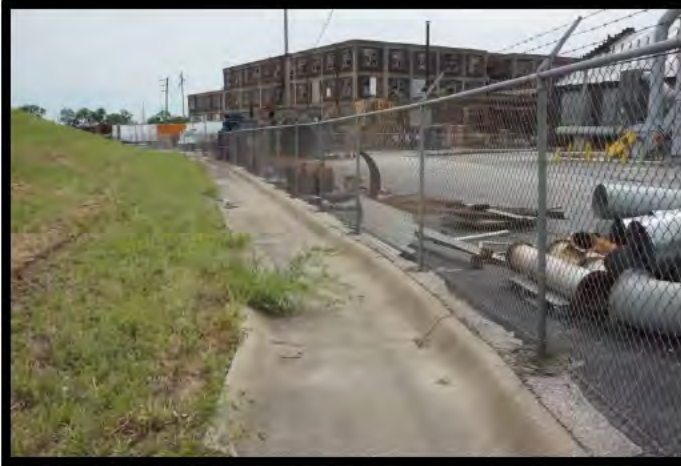
Photograph 27: Concrete drainage swale and vegetation near base of western side of Taracorp pile (view south).

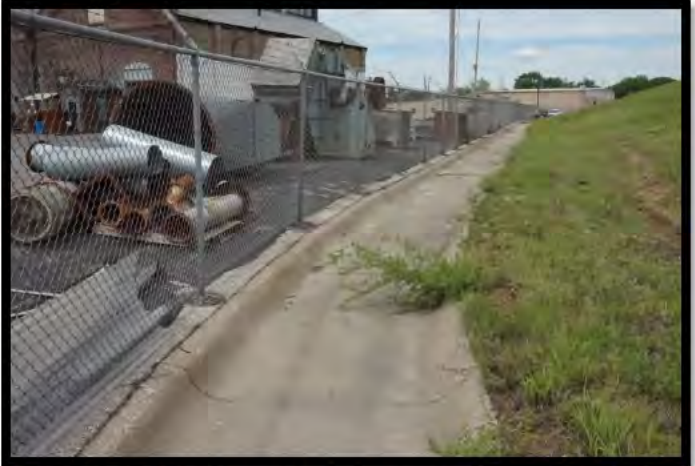
Photograph 28: Concrete drainage swale and vegetation near base of western side of Taracorp pile (view north).

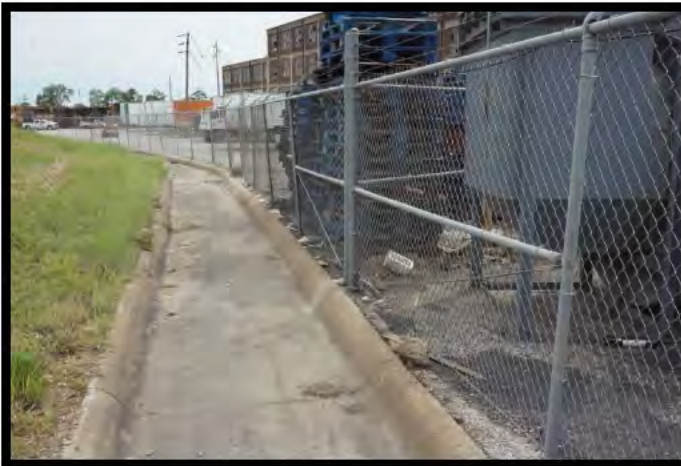
Photograph 29: Concrete drainage swale, western side of Taracorp pile (view south).

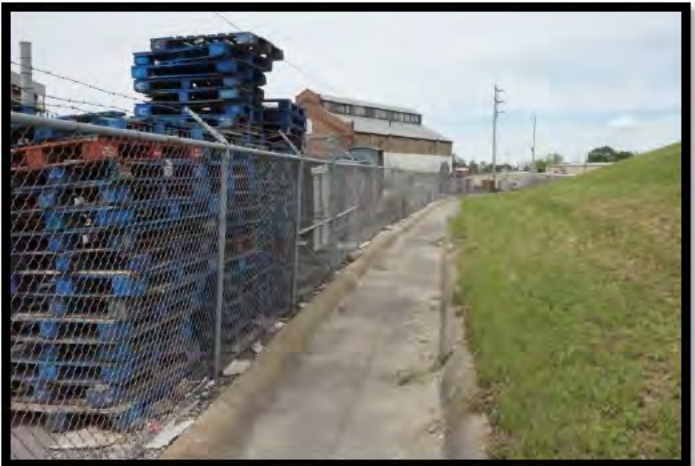
Photograph 30: Concrete drainage swale, western side of Taracorp pile (view north).

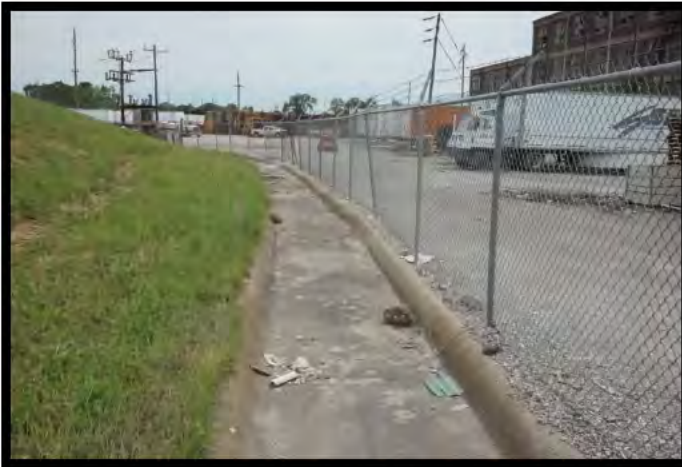
Photograph 31: Concrete drainage swale and vegetation near base of western side of Taracorp pile (view south).

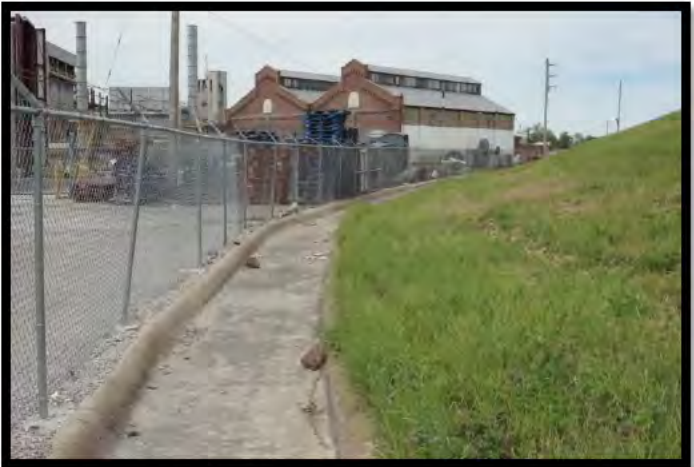
Photograph 32: Fence and concrete drainage swale, southwestern side of Taracorp pile cap.

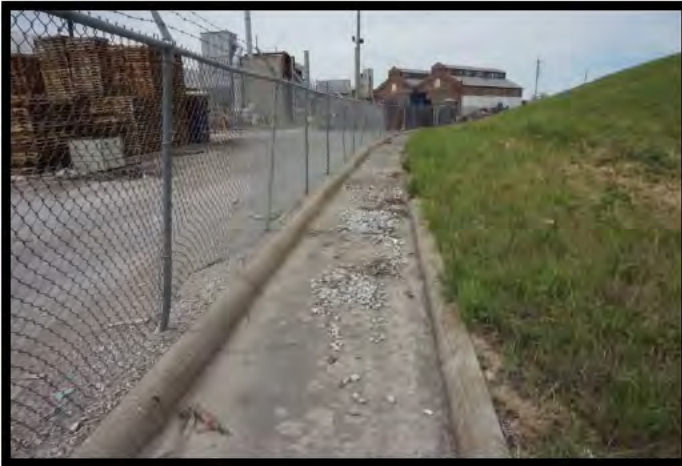
Photograph 33: Fence and concrete drainage swale, southwestern side of Taracorp pile cap.

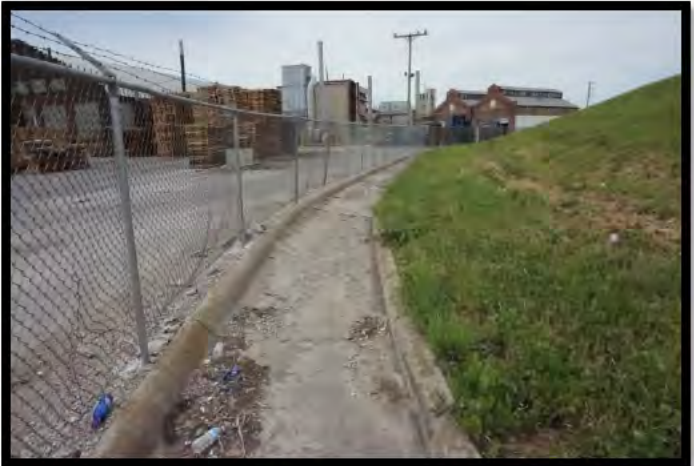
Photograph 34: Fence and concrete drainage swale, southwestern side of Taracorp pile cap.

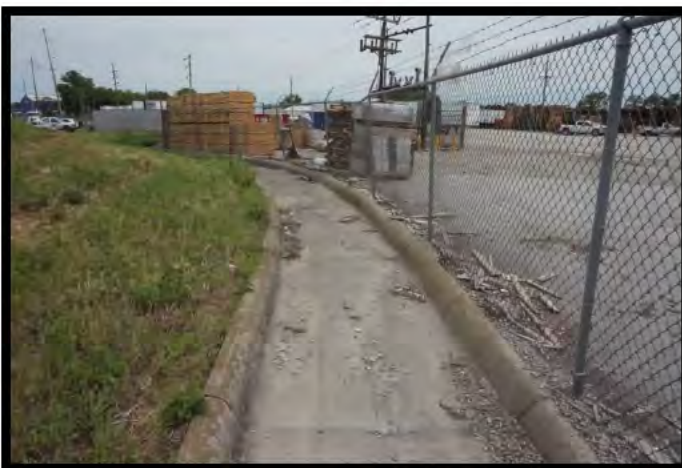
Photograph 35: Fence and concrete drainage swale, southwestern side of Taracorp pile cap.

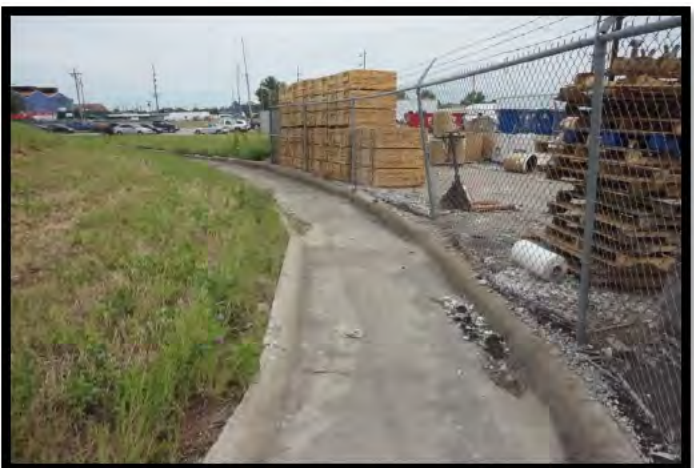
Photograph 36: Fence and concrete drainage swale, southwestern side of Taracorp pile cap.

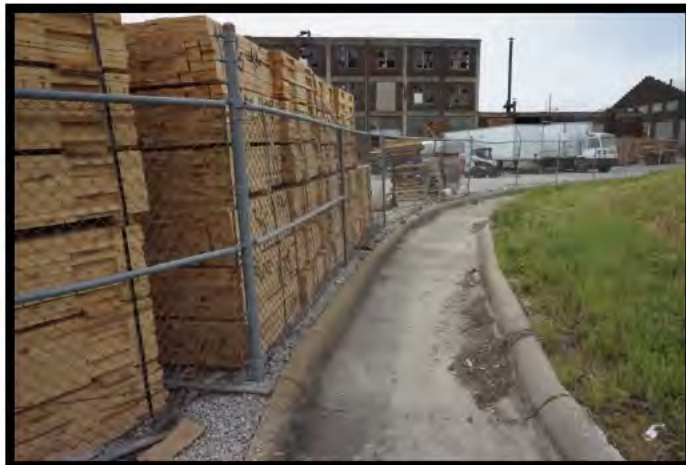
Photograph 37: Fence and concrete drainage swale, southwestern side of Taracorp pile cap.

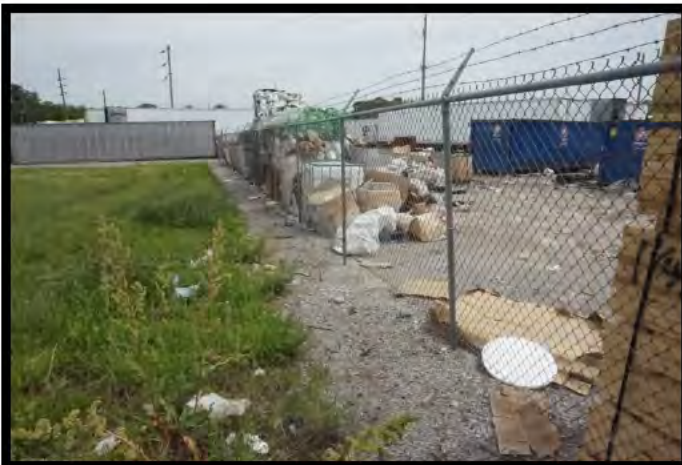
Photograph 38: Fence (material staging on State Street Warehouse property).

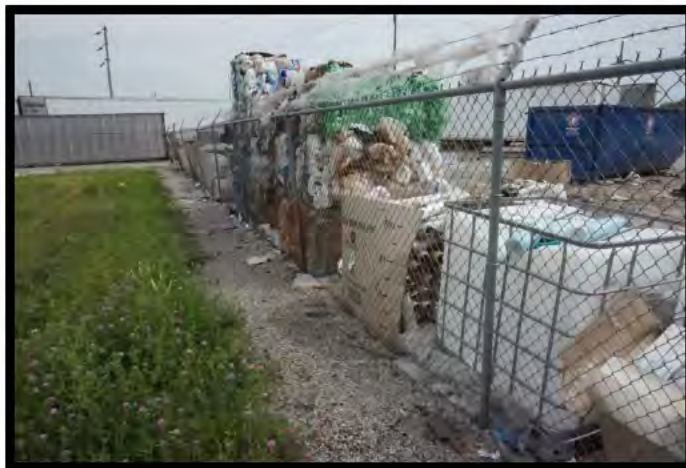
Photograph 39: Fence (material staging on State Street Warehouse property).

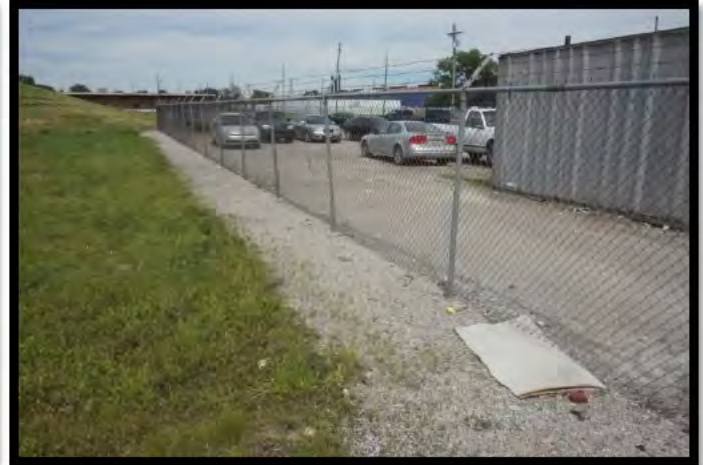
Photograph 44: Fence along State Street Warehouse property.

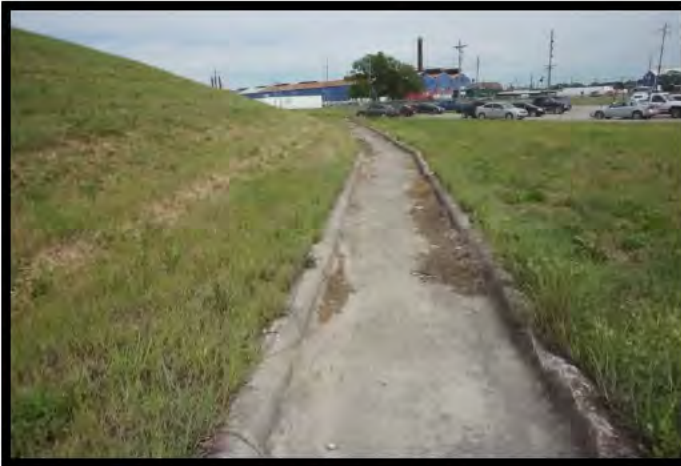
Photograph 45: Concrete drainage swale along southern slope of Taracorp pile.

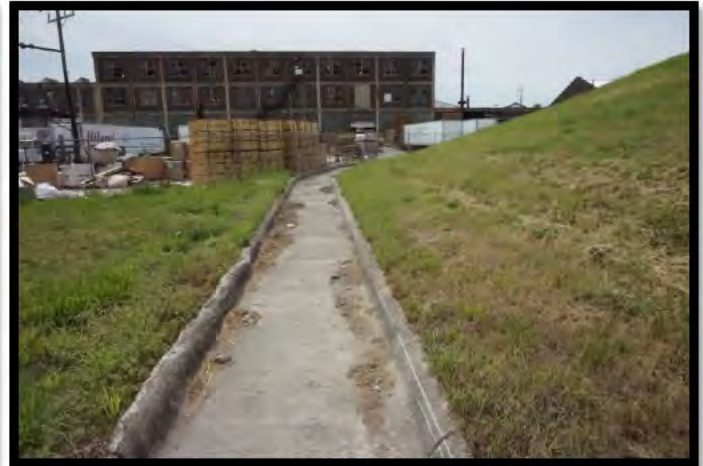
Photograph 46: Vegetation and concrete drainage swale along southern slope of Taracorp pile (view west).
